TECHNICAL REPORT REMR-CO-3

CASE HISTORIES OF CORPS BREAKWATER AND JETTY STRUCTURES

Report 2
SOUTH ATLANTIC DIVISION

Francis E. Sargent

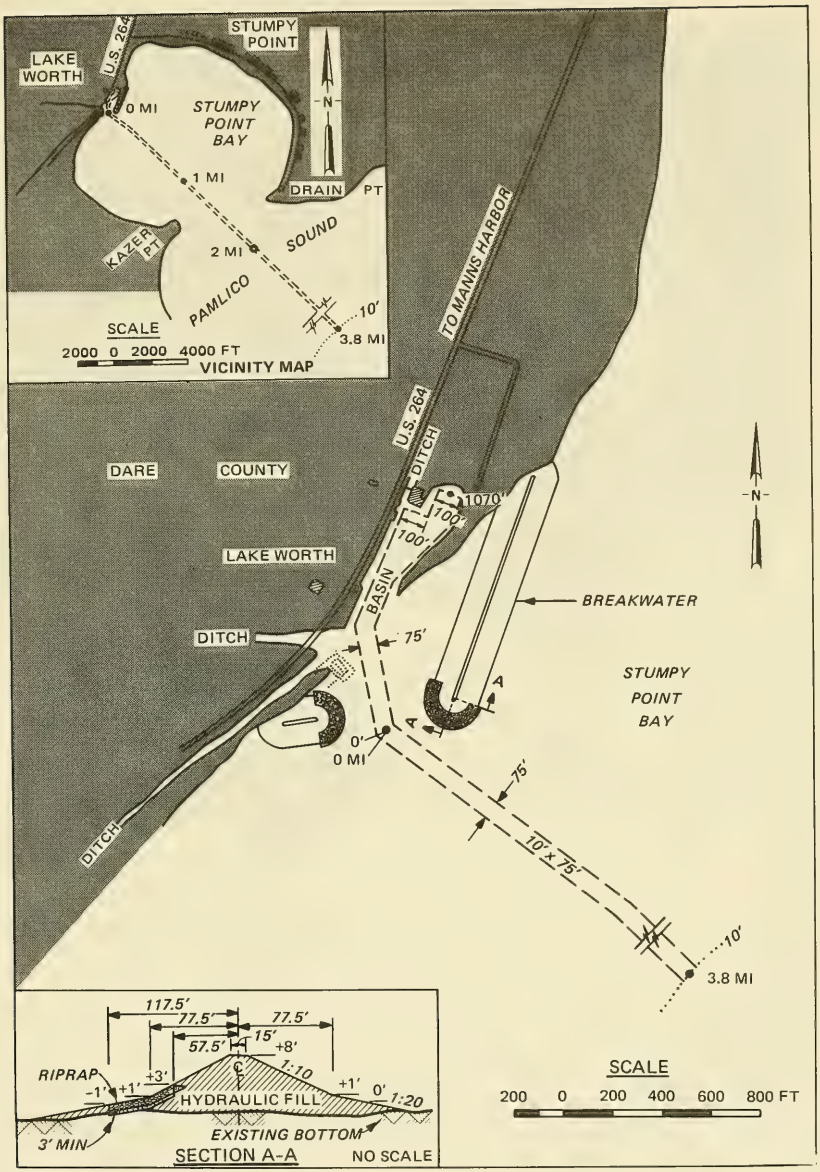
Figure 4. Stumpy Point Bay, North Carolina

1974	A reconnaissance survey was made to determine the severity of erosion to the breakwaters. It was found that the riprap protected sections were functioning satisfactorily but that the fill material adjacent to the riprap sections had substantially eroded. Maximum vertical scarps of 7, 3, and 3 ft, respectively, were noted on the bay and harbor sides of the north breakwater and bay side of the south breakwater. The erosion on the north breakwater was on directly opposite sides of the breakwater with only 30 ft of original material separating the narrowest point. It was felt that "the southeasterly wind with its associated fetch is very erosive to the breakwaters on both sides of the dredged channel."
1985	Neither repairs nor maintenance has been carried out since the breakwaters were originally constructed.

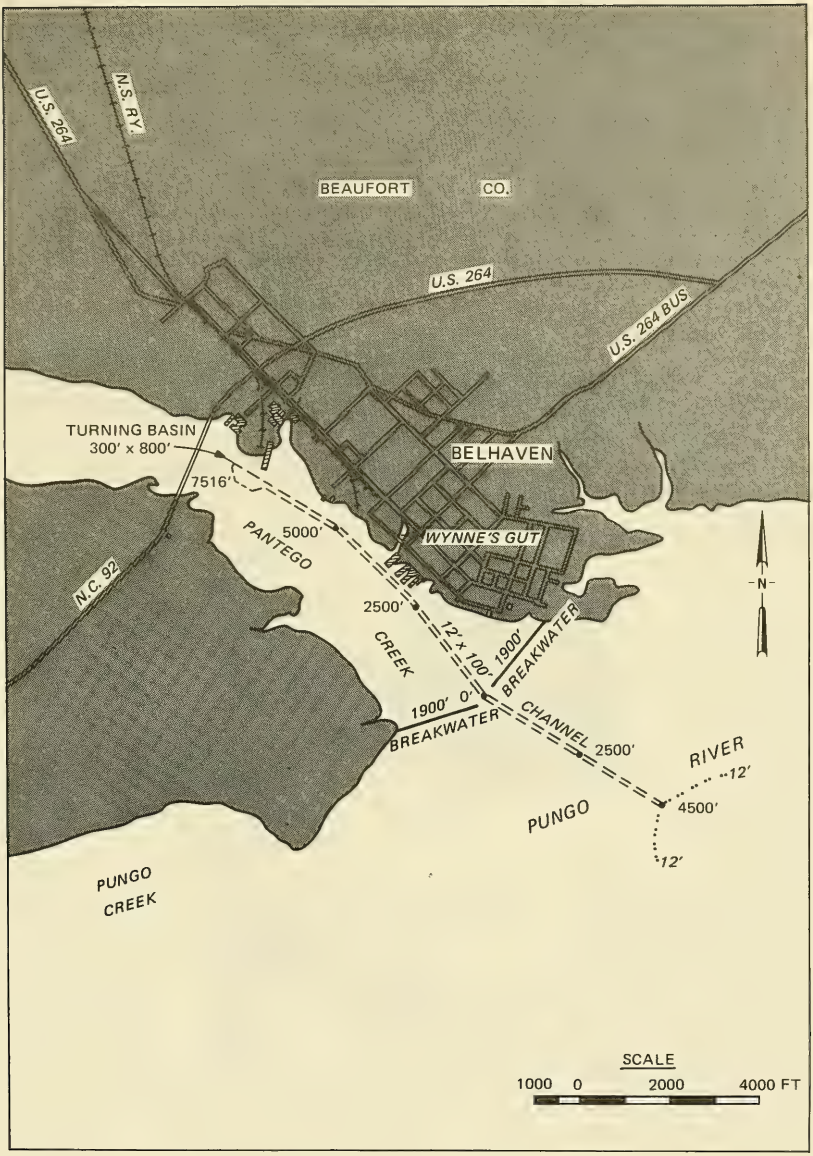
Figure 5. Belhaven Harbor, North Carolina

1982	Visual examination showed that approximately three dozen timbers were missing over the length of the breakwaters. Also, a few pilings were missing. It was thought that the damage resulted from the impact of transient barges tied to the structure.
1985	The structure does not provide its intended wave protection, but at present there are no plans for improvement.

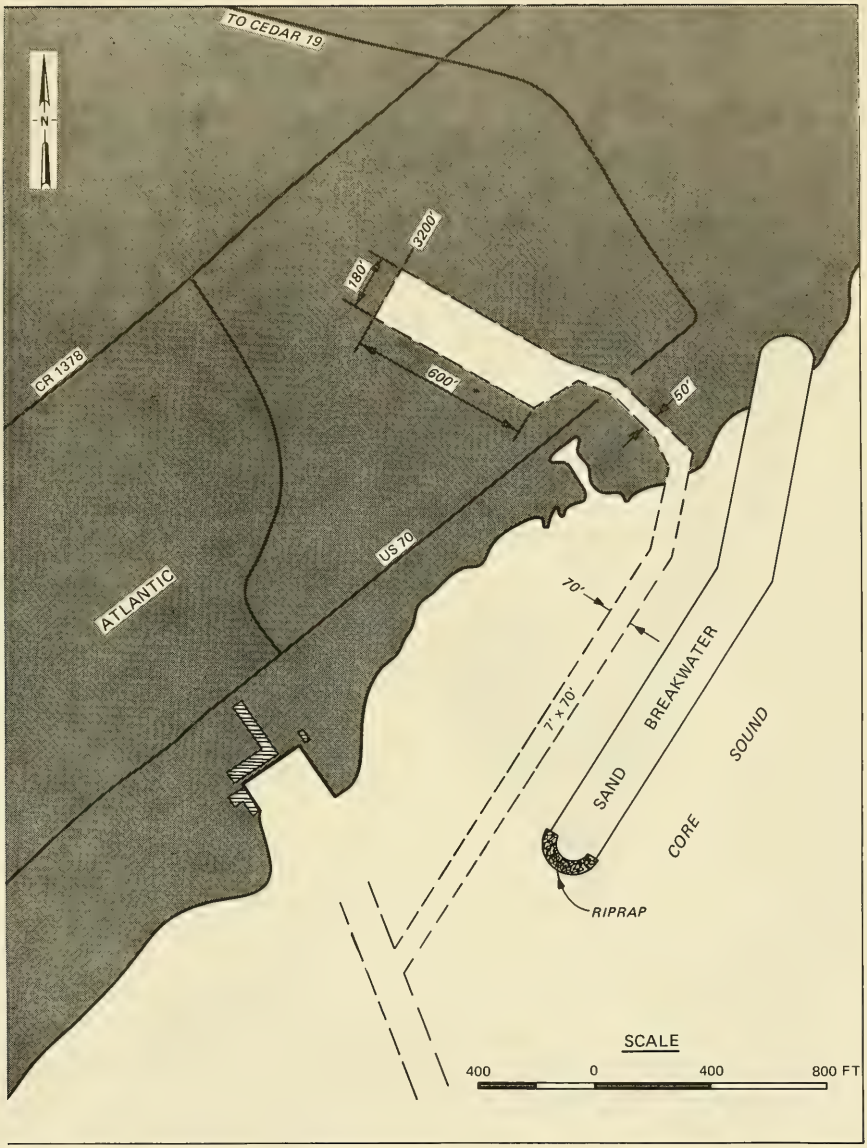
Figure 8. Atlantic Harbor of Refuge, North Carolina

Date(s)	Construction and Rehabilitation History
1971-1972	A 2,000-ft-long sand breakwater (Figure 8) with a riprap head was constructed in February 1972 as part of the Harbor of Refuge project. Material dredged from the access channel was used for the breakwater. A tentative design section called for a crest width of 15 ft at an elevation of +8 ft mlw, with side slopes of 1V:10H above mlw and 1V:20H below. The head of the breakwater would have a 3-ft-thick riprap section from -1 to +3 ft mlw. This design section was similar to the one used on the Stumpy Point Bay breakwaters. Estimated quantities were 46,500 cu yd of sand, 3,232 tons of stone, and 6.5 acres of grass (to hold the sand in place). The estimated total cost was $51,400.
1973	Erosion had occurred along a 400-ft section of the southeastern face of the breakwater. The erosion extended from 35 to 60 ft into the embankment, creating an escarpment of about 3 ft, and the planted grass had been destroyed in this area. Also, the stone protection on the south end of the breakwater (previously covered with sand) had become uncovered, displaced, and scattered. The sand fill behind the stone apparently eroded away first, undermining the rock and subsequently displacing it.

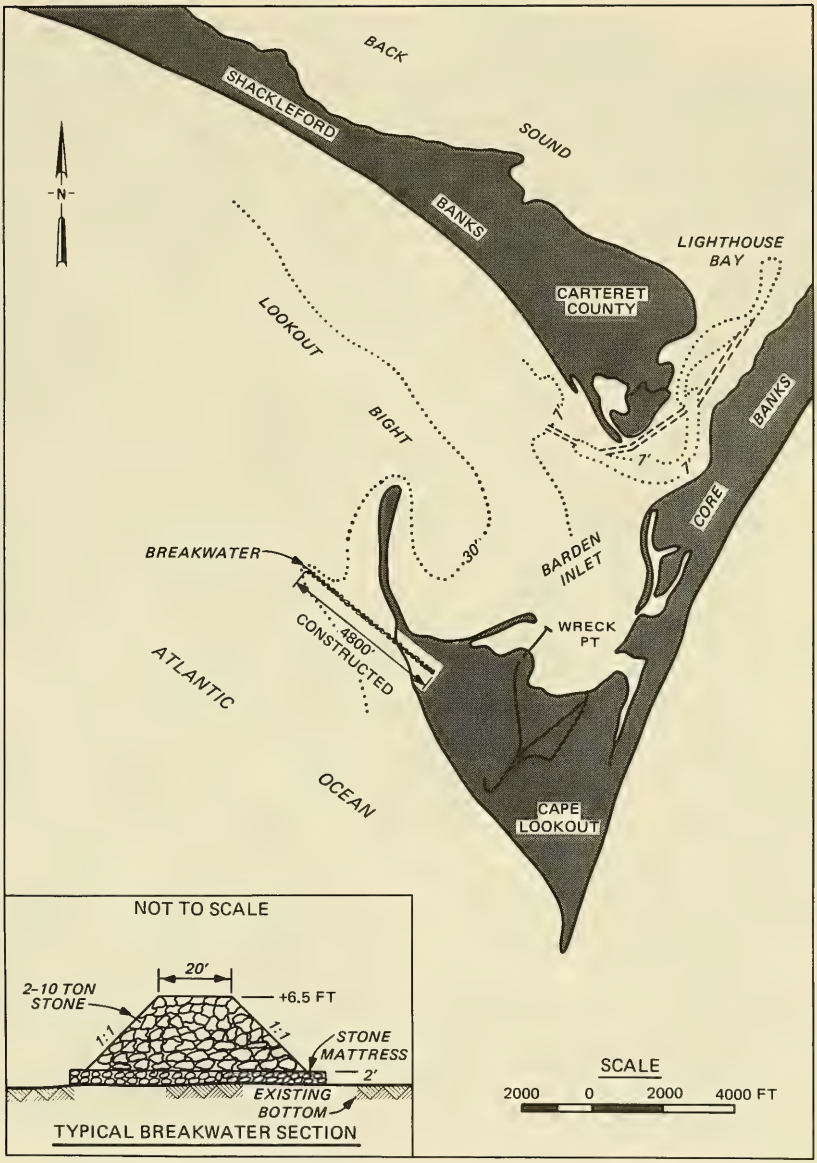
Figure 9. Cape Lookout Harbor of Refuge, North Carolina

Date(s)	Construction and Rehabilitation History
1914-1917	The landward 4,800 ft of a 7,500-ft-long rubble-mound breakwater (Figure 9), authorized by Congress in 1912, was completed in 1917. Subsequently it was determined that the remaining 2,250 ft of the structure was not needed. The breakwater was constructed on a 2-ft-thick stone mattress. Specifications for the breakwater called for quarry-run stone graded so that at least 10 percent was greater than 10 tons, at least 40 percent greater than 7 tons, and at least 70 percent greater than 2 tons. The design section had a 20-ft crest width at +6.5 ft mlw with 1V:1H side slopes. About 651,400 tons of stone were placed at a total cost of $1,363,800. (The cost included some other items such as constructing sand fences, a survey boat, and paying for rights-of-way.)
1921	In December cross sections were taken of the breakwater. They showed that the average top elevation of the breakwater was at mlw. The side slopes near the top were fairly flat (about 1V:2H to 1V:3H), and the lower part of the side slopes was fairly steep, generally 1V:1H. At that time the breakwater was visible only in places at extreme low water.

1985	Since its completion no maintenance or repairs have been made. Because of a sand spit in the lee of the structure, which results in a natural harbor, no plans exist to restore the breakwater to its original condition. (The breakwater was deauthorized on 1 November 1981.)

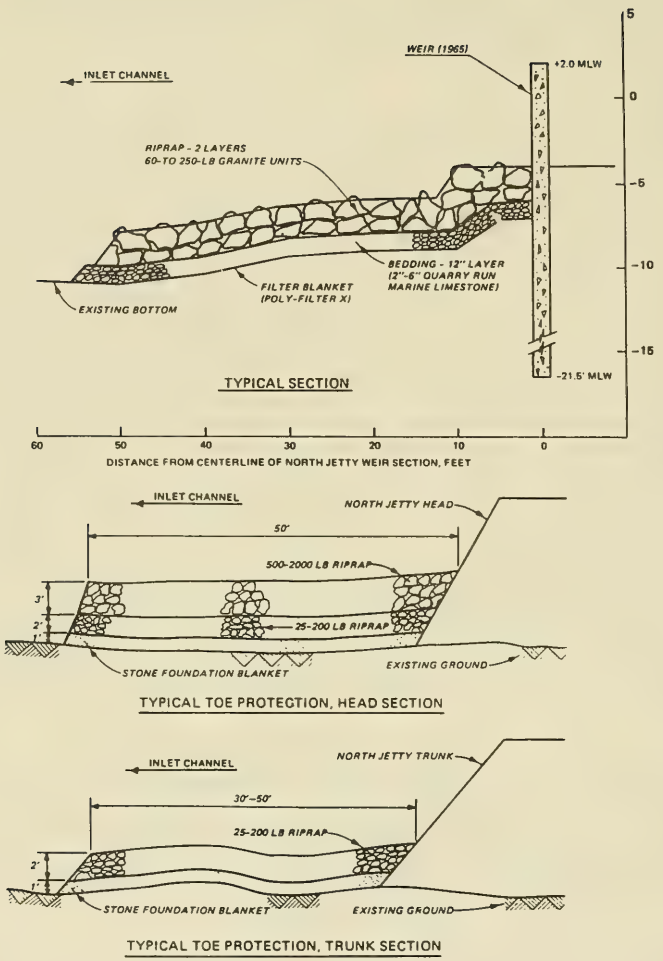
Figure 12. North jetty toe protection
Masonboro Inlet

1973-1974	Toe protection (Figure 12) was placed along the channel side of the 1,100-ft weir section because of continued movement of the navigation channel and the costs involved should a catastrophic failure occur (loss of sheet-pile sections resulting from scour and undermining). The toe apron was to be 50 ft wide with a 1-ft-thick foundation blanket of 2- to 6-in. stone overlain with a 2.5-ft layer of 25- to 250-lb riprap. Total cost of the repair was $248,800.
1978-1980	Construction of the south jetty, built of quarry stone and concrete sheet pile to a length of 3,450 ft, began in July 1978 and was completed in August 1980. A bathymetric survey taken in 1978 showed the channel to be extremely close to the north jetty with water depths up to -25 ft mlw along the rubble-mound section and -12 ft mlw along the weir jetty section. Model tests of the south jetty alignment and geometry, conducted at the US Army Engineer

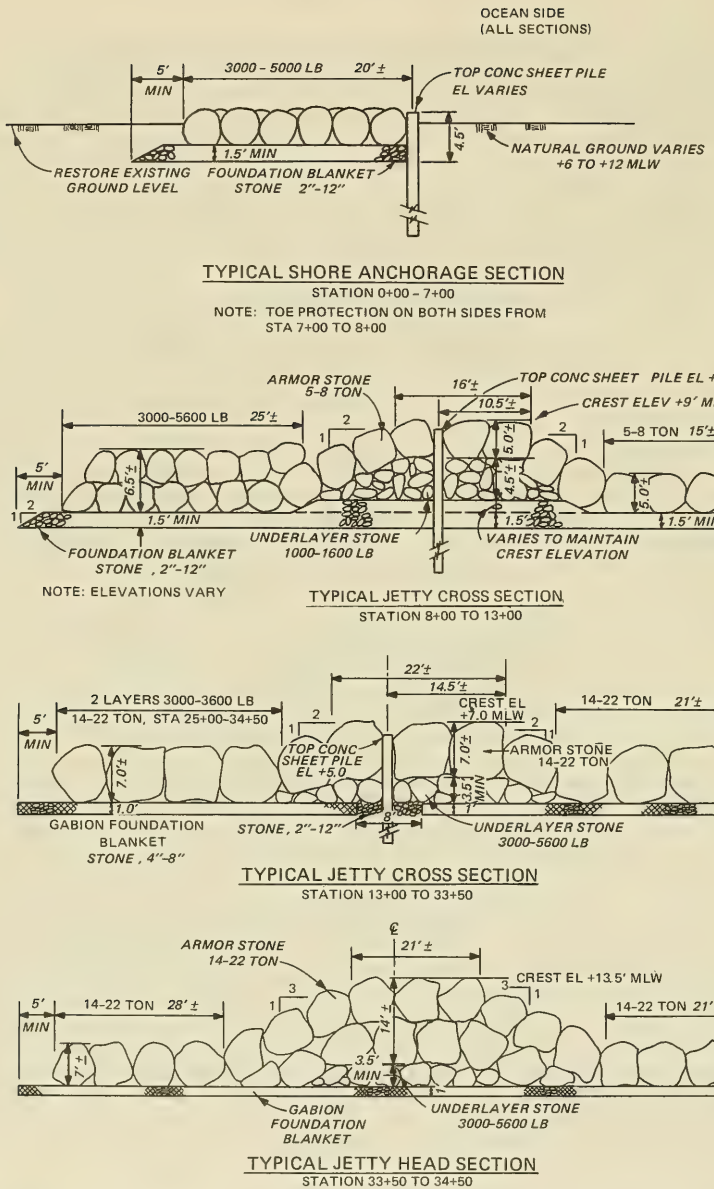
Figure 13. Typical south jetty cross sections, Masonboro Inlet

1985	Presently, the south jetty is in good condition; whereas, the north jetty, which was constructed of smaller size armor stone, is in need of repair work in several areas showing localized armor stone damage.

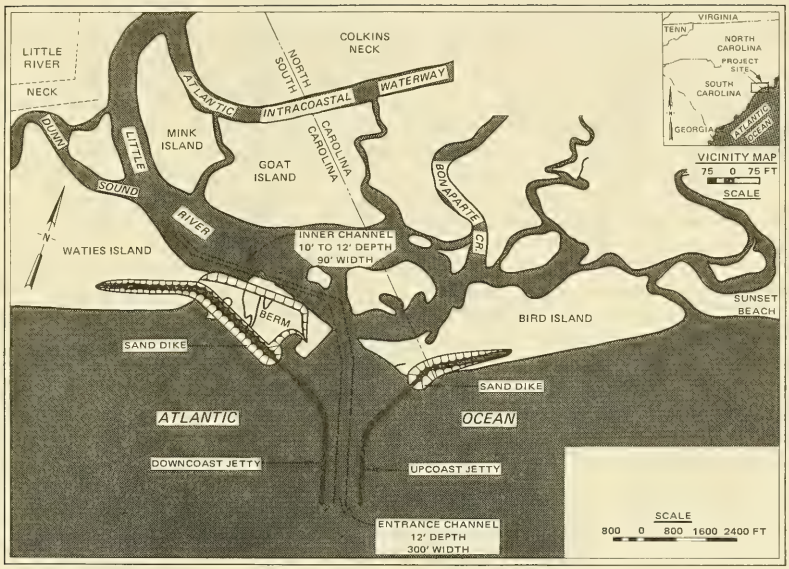
Figure 14. Little River, South Carolina

1986	A visual examination of the structures indicated some displaced stone along the weir section of the north jetty. Surveys also revealed scour holes at the head of the north jetty and along the channel side of the south jetty. No apparent jetty damage was indicated above the water surface. Damage along the toe of the structures, if any, is unknown.

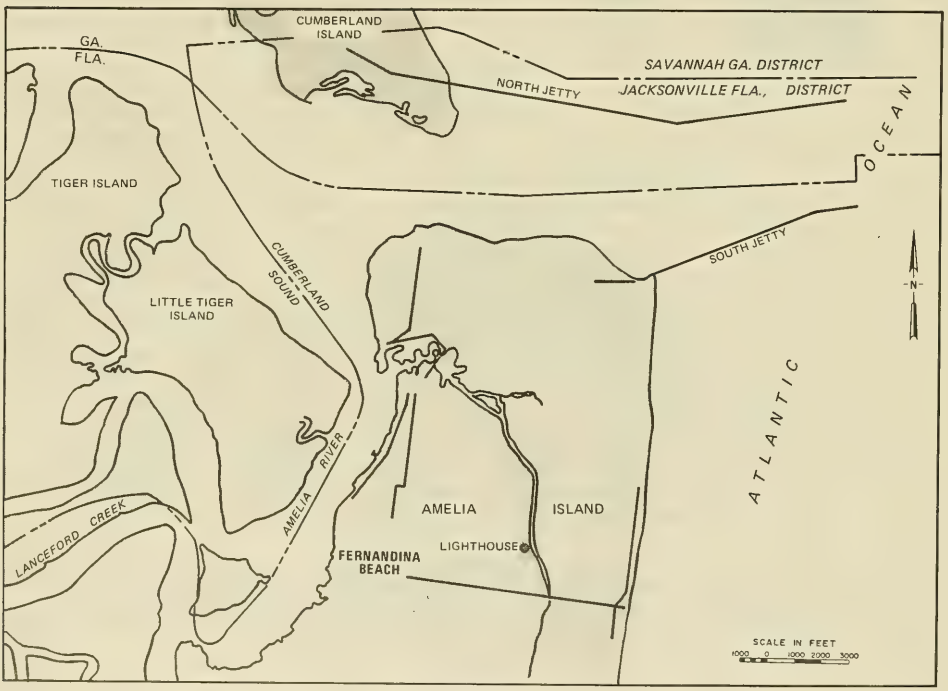
Figure 21. Fernandina Harbor jetties, Florida

Date(s)	Construction and Rehabilitation History
1937	A survey in May showed crest heights of +2.5 to +8.5 ft mlw and +2.0 to +9.0 ft mlw for the north and south jetties, respectively.
1945	A survey of the south jetty in December showed crest heights from +1.5 to +9.0 ft mlw.
1985-1987	At present, a 40-ft-deep by 400-ft-wide channel between the jetties is maintained by the Navy (the Federal project depth is 32 ft). A contract has been awarded to sand-tighten the landward 1,500 ft of the south jetty. (As of 17 Aug 87 the job had not been completed.) Plans call for removal of the existing jetty to -5 ft mlw, placing an impermeable core of precast concrete sections (inverted Y-shape), and rebuilding to a crown elevation of +9 ft mlw using 8-ton (maximum) armor stone.

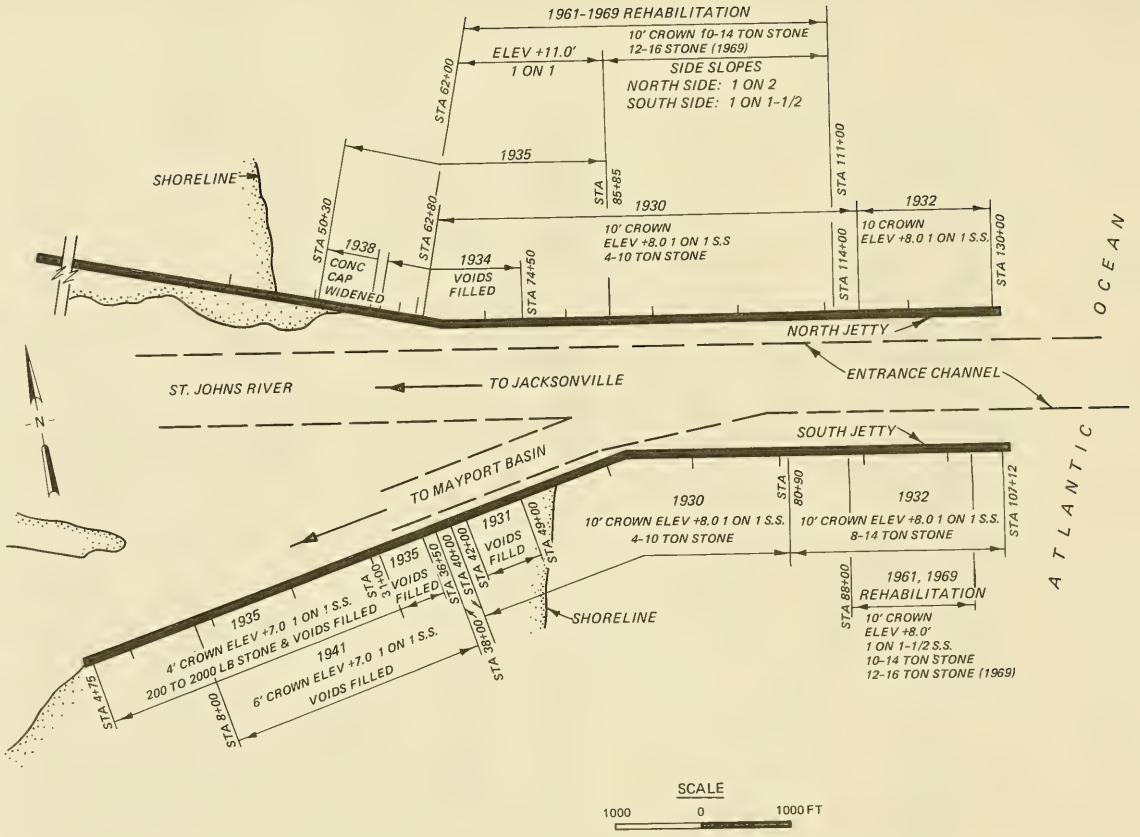
Figure 24. Plan view of cummulative repairs to Jacksonville jetties from 1930 to 1969

1930	Repairs were made between sta 62+80 and 114+00 of the north jetty with 29,700 tons of granite stone (Figure 24). Nine gaps with an average height of +4 to +5 ft mlw were raised to +8 ft mlw. The crest elevations on the outer 500 ft of the jetty were from -5 to -15 ft mlw. The south jetty was repaired between sta 40+00 and 80+90 with 26,600 tons of granite (Figure 25). Twenty major gaps with average heights of +3 to +5 ft mlw were raised to +8 ft mlw. The crest elevations on the outer 700 ft of the jetty were from +3 to -10 ft mlw. The stone size was from 4 to 10 tons with an average size of 6 to 8 tons. The crown width was 10 ft, and the side slopes were 1V:1H. Cost of the repairs totaled $228,000.
1931-1932	Voids below +4 ft mlw on the ocean side of the south jetty were filled with 25- to 100-lb granite stone to stop the flow of sand through the structure, and 3,450 tons of stone were placed between sta 36+50 and 54+00 (Figure 25). A 110-ft-long groin (crest elevation +7 ft mlw) constructed of 550 tons of stone was placed at sta 44+56 on the ocean side of the south jetty to stop the flow of water along the jetty. Later, a head section on the groin was constructed using 245 tons of granite and 50 cu yd of oyster shell. Total cost of the groin was $15,300. The seaward ends of the jetties were repaired (Figure 24), the north between sta 114+00 and 128+60 and the south between sta 88+00 and 106+30. Storm waves had, over time, lowered both jetties and created gaps, necessitating the repairs. Gaps (low points) on the jetties ranged from +3 to +4 ft mlw. The outer 500 ft of the north jetty ranged from -5 to -20 ft mlw, and the outer 700 ft of the south jetty ranged from +3 to -12 ft mlw. The armor stone ranged from 8 to 14 tons, and the design section consisted of a 10-ft crest width at +8 ft mlw and 1V:1H side slopes.

1938	The north jetty concrete cap was widened from the existing 2-ft section to a width of 6 ft between sta 50+30 and 56+60 (Figure 24).
1940-1941	Repairs were made to the south jetty between sta 8+00 and 38+00 (Figure 24). Granite stone of 1 to 3 tons and 3 to 6 tons was placed on the inner 1,200 ft and outer 1,800 ft, respectively. Void filling stone of 50 to 150 lb was placed throughout the repair section. The design called for a 6-ft crown width at +7 ft mlw with 1V:1H side slopes. Sand overlying the jetty was to be removed before stone placement. Small stone was removed between 33+00 and 38+00 as required to allow placing of the cover stone to the design section with the removed stone subsequently used to fill voids. 21,800 tons of 1- to 6-ton stone and 4,800 tons of 50- to 150-lb stone were placed at a cost $105,000.
1961	Rehabilitation made to the seaward end of the south jetty between sta 88+00 and 102+70 and the north jetty between sta 62+00 and 11+100 (Figure 24). Areas of deterioration from settlement and dislodgement of stone had occurred at the ocean ends and along landward portions of both jetties. Also, several portions of the north jetty concrete cap had been broken and displaced from the crown along with some of the underlying support stone. The major causes of settlement seemed to be slope flattening and the possibility of wave

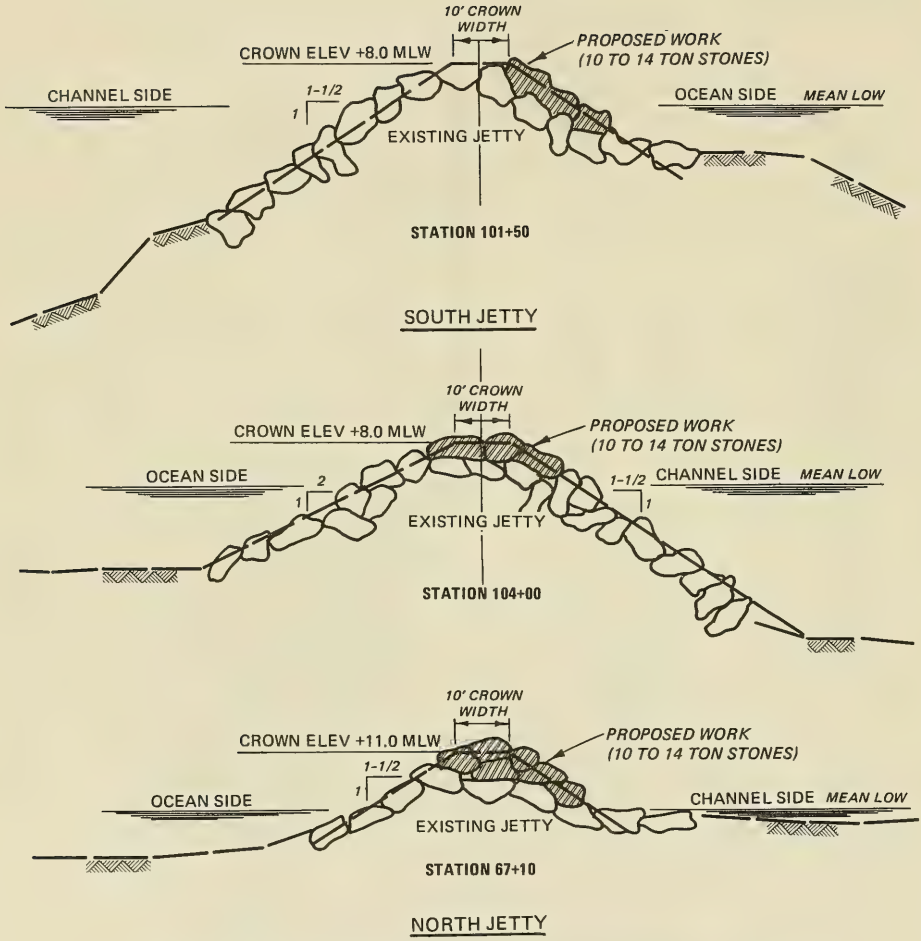
Figure 25. Typical 1961 repairs to Jacksonville jetties

Date(s)	Construction and Rehabilitation History
1961 (Cont)	action causing increased consolidation. Repairs were made to bring the structure back up to previous designs but with larger stone. The design called for 10- to 14-ton granite stone and a crown width of 10 ft for all repair sections (Figure 25). On the concrete cap section of the north jetty, between 62+00 and 85+88, the crown elevation was to be +11 ft mlw, and the side slopes were 1V:1.5H. The remainder of the jetty repairs were to have a +8 ft mlw crown elevation and 1V:1.5H side slopes (with the exception of the north jetty ocean-side slope which was 1V:2H). The design was based on a 14- to 15-ft wave height and Hudson's stability equation. Cost of the rehabilitation with 5,500 tons of stone was $54,600.
1969	Rehabilitation of jetties was carried out on approximately the same section as the 1961 repairs (Figure 25). Except for the use of 12- to 16-ton stone, the design sections were identical to those of 1961. The north jetty from sta 50+45 to 85+80 was built up to +11 ft mlw with 1V:1.5H side slopes and from sta 85+80 to 122+80 was built up to +8 ft mlw with 1V:2H and 1V:1.5H side slopes on the ocean and channel sides, respectively. The south jetty from sta 85+90 to 103+20 was built up to +8 ft mlw with 1V:1.5H side slopes. The crown width on all sections was 10 ft. Dislocation and consolidation of cover stone overlying smaller stone (below mlw) was thought to be the cause of jetty deterioration. The low areas to be repaired were wide which provided a good base to place new stone. Wave heights of 14 and 15 ft and Hudson's stability equation were used, similar to those in the 1961 design. A total of 21,500 tons of stone was placed at a cost of $398,000. Inner areas of the jetties were not rehabilitated although in need of some repairs.

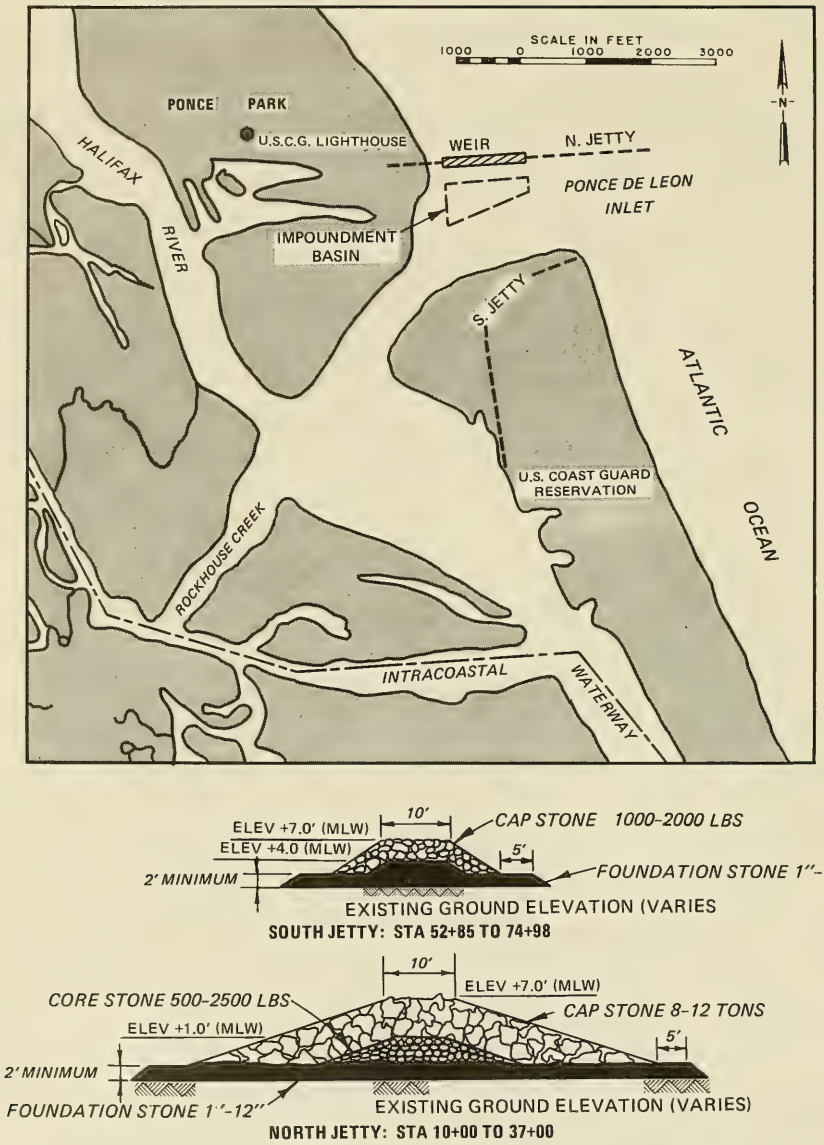
Figure 29. Ponce de Leon Inlet, Florida

Date(s)	Construction and Rehabilitation History
1981	Erosion at the root of the north jetty required placing stone over a 375-ft section of the existing jetty beginning 125 ft from landward end. The repair cross section consisted of a 1.5-ft layer of 1- to 50-lb bedding stone, a core of 30- to 1,000-lb stone, and 0.5- to 2-ton capstone. Side slopes were 1V:2H with a 5-ft crest width and crest elevations varying from +9 to +12 ft mlw. Additionally, 1,150 tons of bedding stone, 1,970 tons of capstone, and rearrangement of stockpiled core stone were used in the repair.
1982-1983	The north jetty weir section was closed using core and armor stone (no details). Armor stone size and cross-section geometry were similar to those for the existing rubble-mound section at the seaward end of the weir section.
1985	The jetties are presently in good condition except for some damage on the north jetty head because of a recent storm and continued erosion at the root of the jetty.

1978	A blanket of armor stone was placed at the base of the north jetty along the seaward 2,550 ft. A total of 23,100 tons of up to 700-lb riprap stone and 9,100 tons of 500-lb to 3-ton stone (75 percent greater than 1 ton) was placed. The cost of the repair was $1,453,000.

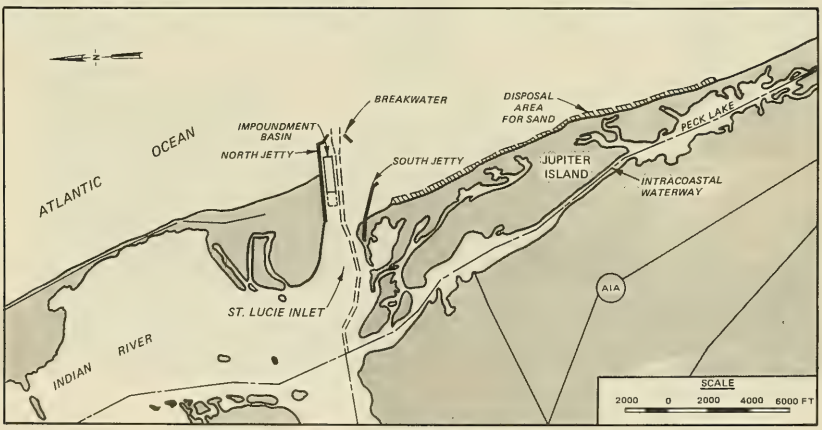
Figure 32. St. Lucie Inlet, Florida

1985	Although structurally sound, it is functionally unsatisfactory (i.e. maintaining the required channel depth), and a major rehabilitation is in the planning states.

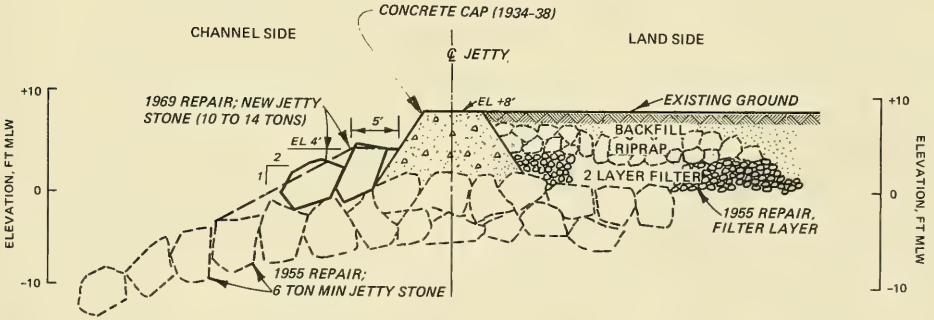
Figure 34. Palm Beach north jetty repairs of 1955 and 1969

Date(s)	Construction and Rehabilitation History
1967-1968	The harbor was deepened to 35 ft. Federal support of the sand transfer plant ended.
1969	Rehabilitation of the 550-ft seaward section of the north jetty was made with 10- to 14-ton capstone on 1V:2H-side slopes (Figure 34). A total of 2,000 tons of armor stone was placed at a cost of $83,000. A design wave height of 15 ft and a 14-sec wave period were used to select the capstone size.
1985	Present plans call for repairs to 1,300 ft of the south jetty. The jetty would be made impervious to sand motion via injection of silicate grout on the shoreward 800 ft and via a rubble filter on the seaward 500 ft. For slope protection, 5- to 10-ton stone were placed on 200 ft of the channel side (near shoreward end). The design wave height of 12.7 ft (obtained using the method outlined in Seelig and Ahrens (1980) used to compute size of cover stone to provide protection of the filter layer on the seaward end of repair). Cover stone will be 8 to 14 tons with an underlayer of 800- to 2,400-lb stone and 3- to 6-in. filter stone. The estimated first cost is $2.2 million.

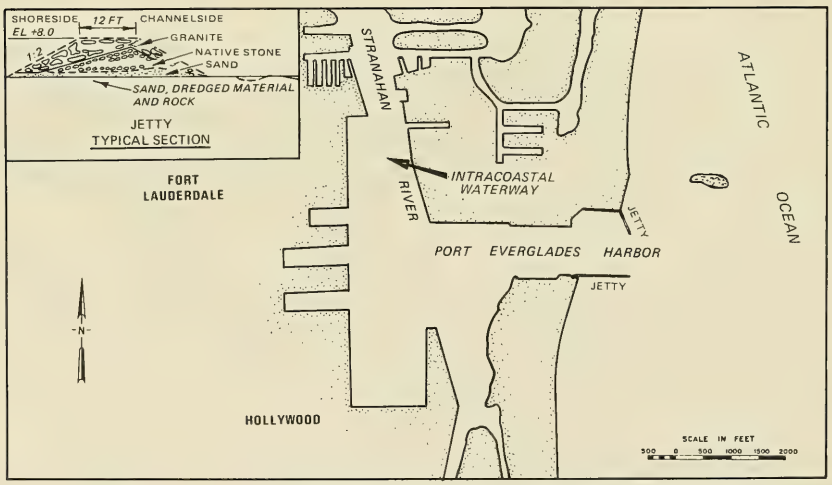
Figure 35. Port Everglades Harbor, Hollywood, Florida

1984-1985	The inner ends of the jetties were repaired by rebuilding the armor stone layer with new and existing stone. To allow the jetties to be used as fishing piers, void spaces were chinked with smaller stone, and a layer of asphalt was piled on the crown. Prior to the repairs, the inner ends were in very poor condition with numerous void spaces while the remaining parts of the jetties were considered to be in satisfactory condition.

1932	Repairs made to the jetties consisted of placement of 2- to 10-ton granite stone to a height of +6 ft mlw, a crest width of 12 ft, and side slopes of 1V:2H. In addition, some old stone (about 400 pieces each weighing 1,000 lb or more) was rehandled in the construction phase. Total estimated quantities of stone were 4,900 and 5,230 tons for the north and south jetties, respectively. Total cost of the repair was $49,400.
1935	A field survey showed approximate lengths of 1,250 and 1,000 ft for the north and south jetties, respectively. Centerline elevations on the north jetty range from +10 to +5 ft mlw over the shoreward (old) 500 ft and from +4 to +8 ft mlw over the seaward (repaired) 750 ft. Centerline elevations on the south jetty range from +9 to +7.5 ft mlw over the shoreward (old) 300 ft and from +9 to +4 over the seaward 700 ft. The outer 100 ft of each jetty appeared to have subsided 1 to 2 ft from the design elevation of +6 ft mlw.

Date(s)	Construction and Rehabilitation History
1940 (Cont)	the north and south jetties, respectively. The outer 990 ft and 450 ft of the north and south jetties were brought up to +8 ft mlw with a 12-ft crest and 1V:2H side slopes (Figure 35, inset). The head section of each jetty had a +15-ft mlw crest elevation, a 24-ft-diam crest, and 1V:2H side slopes radiating away from the crown. A total of 18,900 tons of 4- to 12-ton granite stone was placed. (Other work consisted of placing 750 tons of 25- to 150-lb chinking stone and handling of 1,200 pieces of old stone.) Total cost of the repairs was $142,700.
1978-1979	As part of harbor deepening improvements, the seaward 200 ft of the north jetty was realigned parallel to the entrance channel (Figure 35). The realignment allowed the channel width between the jetties to be increased from 300 to 450 ft. The estimated realignment cost was $75,000.

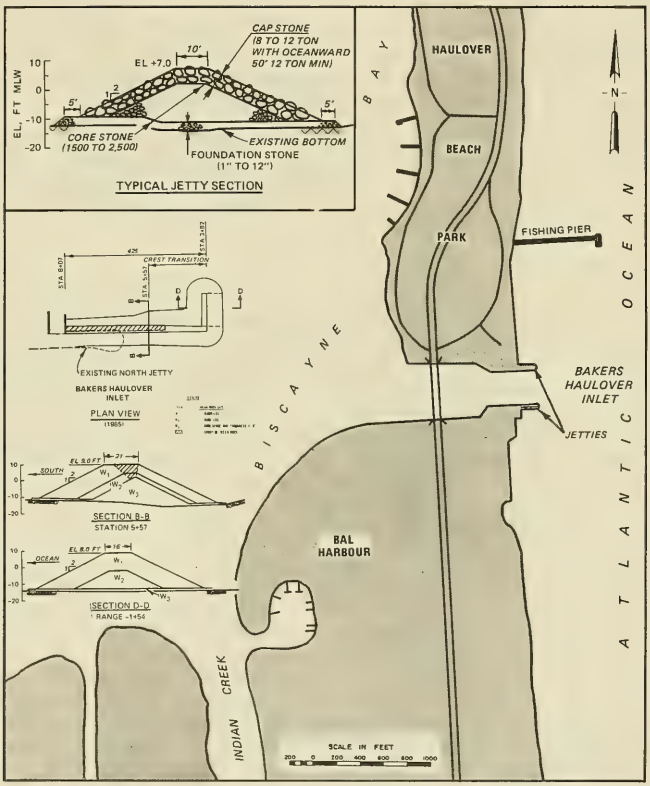
Figure 36. Bakers Haulover Inlet, Florida, 1964

Date(s)	Construction and Rehabilitation History
1925	A man-made inlet was constructed by local interests.
1963-1964	Existing steel sheet-pile jetties (private construction, date unknown) had rusted through, and wave action had partially removed sand fill behind them. Loss of this fill caused the collapse of portions of an 8-in. concrete cap on both jetties. The sheet-pile jetties were removed and 150-ft-long rubble-mound jetties were constructed in their place (Figure 36). The jetty section consisted of 1,500- to 2,500-lb and 8- to 12-ton stone for the core and cap, respectively. 12-ton minimum cap stone was placed on the outer 50 ft of the jetties. The side slopes were 1V:2H with a crown width and elevation of 10 ft and +7 ft mlw, respectively. The design was based on a wave height of 14 ft and Hudson's slope stability formula. The centerline distance between the jetties was about 415 ft, the south jetty being placed about 100 ft south of the sheet-pile jetty. The channel was dredged to -11 ft mlw. Total cost of the jetties and connecting revetments was $417,000.

1974	The south jetty was extended by non-Federal interests (Bal Harbour Village, no details) with subsequent reimbursement of applicable Federal share of costs. The 735-ft extension consisted of an armor stone jetty capped with concrete. The seaward end curves 90 deg (quarter circle) away from the inlet.
1985	The north jetty was essentially rebuilt to act as a sand-tight terminal groin since the existing jetty would not be effective in maintaining the planned beach renourishment north of, and adjacent to, the jetty. Prior to being rebuilt, an inspection indicated that the jetty had held up well since its construction but that it was ineffective in retaining sand which passed through it and around its seaward end. A general design memorandum describes the rebuilt jetty (though it appears some design change(s) have occurred) as follows: "a concrete block has been added to the jetty section, which has decreased the amount of rock required substantially." The 525-ft-long north jetty had a 425-ft section parallel to, and approximately 30 ft north of, the old jetty and a perpendicular section at the seaward end extending away from the channel (Figure 36, inset). The crest elevation of +9 ft mlw along the 425-ft section decreased to 7 ft between the "heel" and "toe" of the 100-ft section. A crest width of 21 ft extended over the innermost 250 ft, decreased to 16 ft at the heel, and then remained constant out to the toe. Side slopes were 1V:2H. The jetty section was made up of three layers; the innermost core and foundation layer of 1- to 12-in. stone, and two armor stone layers, an underlayer of 1,200- to 2,000-lb stone and a cover layer of 6- to 12-ton stone. Concrete grout was placed along the inner 300 ft of the jetty, over 15 ft of the crest width,

Date(s)	Construction and Rehabilitation History
1985 (Cont)	and extended down to the core layer, thus creating a sand-tight jetty section. The estimated quantity of stone and cost were 34,000 tons and $3,016,000, respectively. The design of the jetty was determined from several aspects, including (a) using the Wave Information Studies (WIS) 20-yr wave hindcast study to determine potential annual damage, a technique identical to that used in the design of the Arecibo breakwater and (b) using the N-line shoreline model of Perlin and Dean (1983) to determine the jetty length. The foundation material underlying the jetty consists of very shelly sand overlying limestone strata. The limestone varies in elevation from -15 to -20 ft mlw.

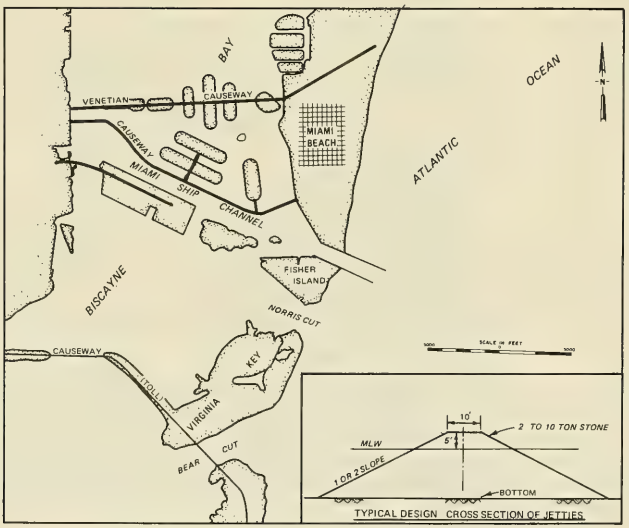
Figure 37. Miami Harbor, Florida

1985	Presently a 38-ft-deep by 400-ft-wide channel is maintained between the jetties. Except for the sand-tightened portion (1983), the jetties have not been repaired since 1934 and, although in poor condition, are still functioning properly.

1929	The jetties and north revetment were repaired. A total of 1,600 ft of the north jetty, 700 ft from its inner end, and 2,200 ft of the south jetty (exclusive of the 1928 extension) was repaired with granite stone to a crest width of 10 ft, an elevation of +5 ft mlw, and 1V:1H side slopes. Stone weighing 13,800 and 18,900 tons was used on the north and south jetties, respectively. The total cost of jetty repairs was $181,000.
1931-1932	Both jetties were surveyed in 1931 and 1932. Centerline elevations for the north jetty were from +9.5 to +4 ft mlw on the inner 2,300 ft and from -3 to +4.5 ft mlw on the outer 1,350 ft. (This section was damaged by storm waves during the survey period.) Centerline elevations for the south jetty varied from +4 to +8 ft mlw.
1933-1934	Based on the previous survey of the jetties, repairs were made to bring the jetties up to the design section. The crest width was 10 ft, the crest elevation was +5 ft mlw, the side slopes were 1V:2H, and the granite stone varied from 2 to 10 tons. Several sections on the north jetty, totaling 2,100 ft, were repaired and a

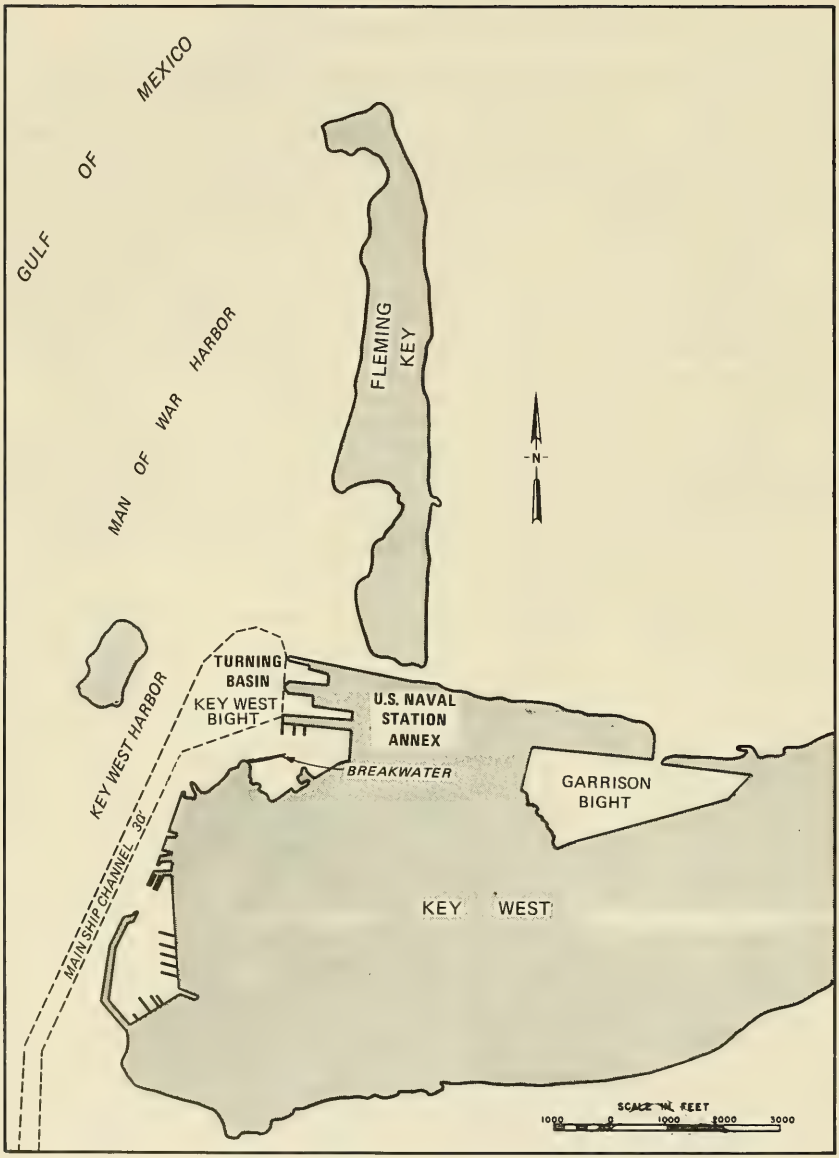
Figure 38. Key West Harbor, Florida

1985	The breakwater has never been repaired and is presently in good condition.

Date(s)	Construction and Rehabilitation History
1967	An 800-ft-long rubble-mound breakwater was constructed to provide harbor protection (Figure 38). The design section consisted of 1- to 12-in. core stone placed to an elevation of 0 ft mlw and overlayed with 2- to 6-ton capstone. The crest elevation was +6 ft mlw, the crest width was 10 ft, and the side slopes were 1V:1.5H. Estimated quantities were 15,100 and 18,800 tons for the foundation material and capstone, respectively. The breakwater design used Hudson's formula with an 8-ft wave height. To prevent potential overtopping, the crest elevation was selected based on a 3.2-ft, 4-sec wave (nonhurricane design wave). The cost of the breakwater plus necessary excavation was $471,000.
1971	A portion of the breakwater was removed to aid in flushing of the harbor. The core stone removed was placed in a blanket 2 ft thick by 15 ft wide extending along one or each side of the breakwater as available stone would permit. The capstone removed was replaced to the existing design with the remainder placed in existing void spaces on the breakwater. The estimated cost of the modification was less than $25,000.

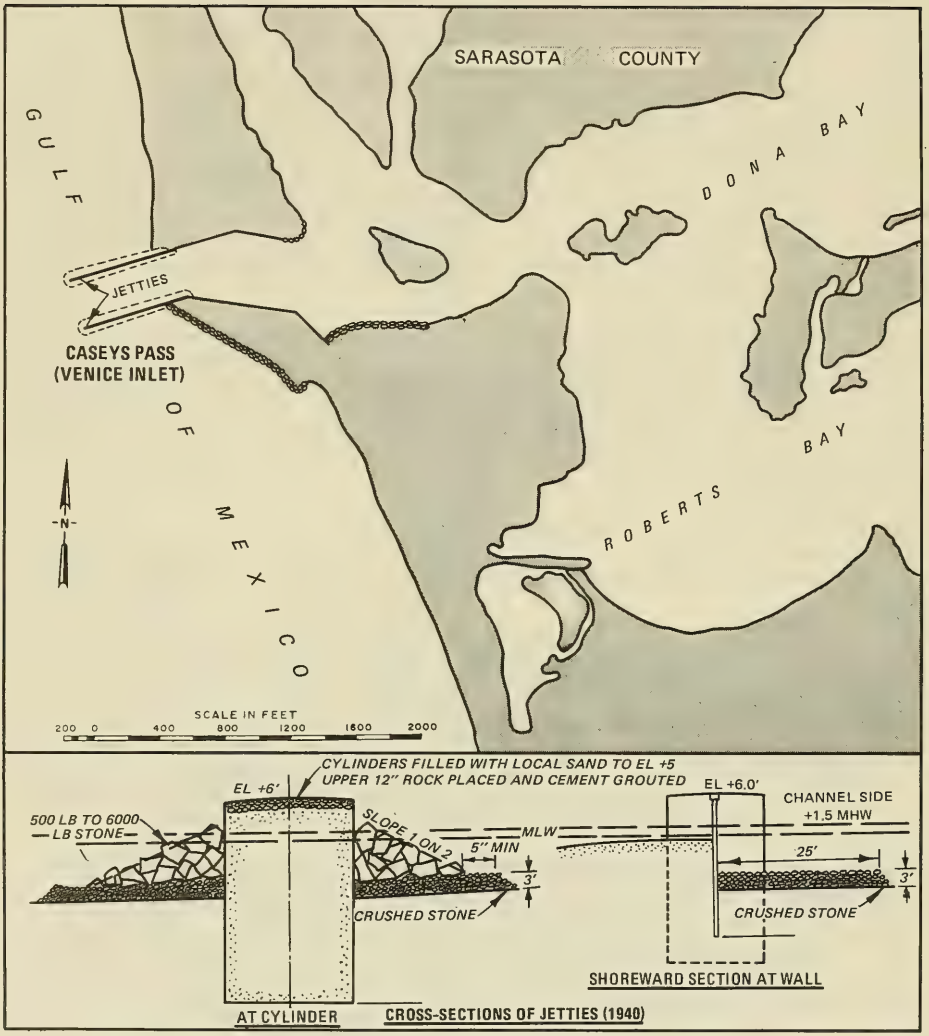
Figure 39. Casey's Pass, Florida

1950-1951	Jetty surveys showed that the heads and seaward sides of the jetties needed repairs. The channel side of the north jetty needed repair because of the proximity of the channel causing scouring at the toe.
1955	Repairs were made to the seaward end of the south jetty which was in a "severely damaged" condition. A total of 650 tons of 3- to 6-ton cover stone was placed on a 2-ft-thick foundation blanket of 2- to 6-in. stone at a total cost of $6,500. Repairs were also made to the collapsed concrete caps on the 1st and 8th caisson from its seaward end. Nearly 3/4 of the first caisson was severely damaged, and 3- to 6-ton cover stone was placed to +6 ft mlw with a 10-ft crown width. The upper 4 ft of the 8th caisson was filled with stone, and the upper foot of this was capped with concrete grout.
1963	Repairs to the concrete cylinder caps and jetty stone/rock revetments were made at a cost of $30,000. At this time, the channel was dredged to a depth of -9 ft mlw. Along the exposed seaward sections, 3- to 6-ton capstone totaling 615 and 770 tons was placed on the north and south jetties, respectively, and approximately 20 capstones were reset. Several of the seaward cylinders were repaired. Their caps and sand were removed to -1 ft mlw, replaced with the broken pieces of the cap and 20- to 200-lb stone, and grouted with concrete throughout the upper 18 in. of stone.

Date(s)	Construction and Rehabilitation History
1968-1969	Visual examinations and detailed surveys showed the sheet-pile cylinders and walls to be in need of immediate repairs. Voids between the original concrete caps and the underlying sand existed in virtually all cylinders not repaired in 1963. Corrosion was the main cause of deterioration, with subsequent removal of sand from the cylinders because of wave and current action. Rehabilitation of the jetties was carried out in 1969 (Figure 40). The sheet-pile walls and cylinders (except the outer two on the north and outer one on the south) were removed down to +2 ft mlw, and the sand within the cylinders were removed to mlw. The existing concrete cap (broken into pieces less than 12 in. long) and 1- to 12-in. bedding stone were placed in the cylinders to +2 ft mlw. This was overlayed with 4- to 10-ton capstone (70 percent > 8 tons), with similar capstone placed along the connecting walls, to bring the structure to the original design elevation of +6 ft mlw with a crown width of 10 ft. Additional 4- to 10-ton capstone was placed, as needed, to bring the side slopes up to 1V:2H. On the outer 50 ft of the jetties, the side slopes were 1V:3H. Finally, asphaltic concrete was placed (Figure 40) on the jetties. This material was placed over the entire crown width down to mlw, and had 1V:1H side slopes. The design of the jetties used Hudson's formula with wave heights of 12 to 16 ft and wave periods of 7 to 9 sec.

1978	Repair to jetties consisted of resetting stone and adding 6- to 12-ton stone (75 percent > 10 ton) on the outer 200 ft of the jetties and 2- to 6-ton stone on the next 450 ft of the jetties as needed to solidify the structure.
1985	The jetties are in good condition except for their head sections which are in need of some repair.

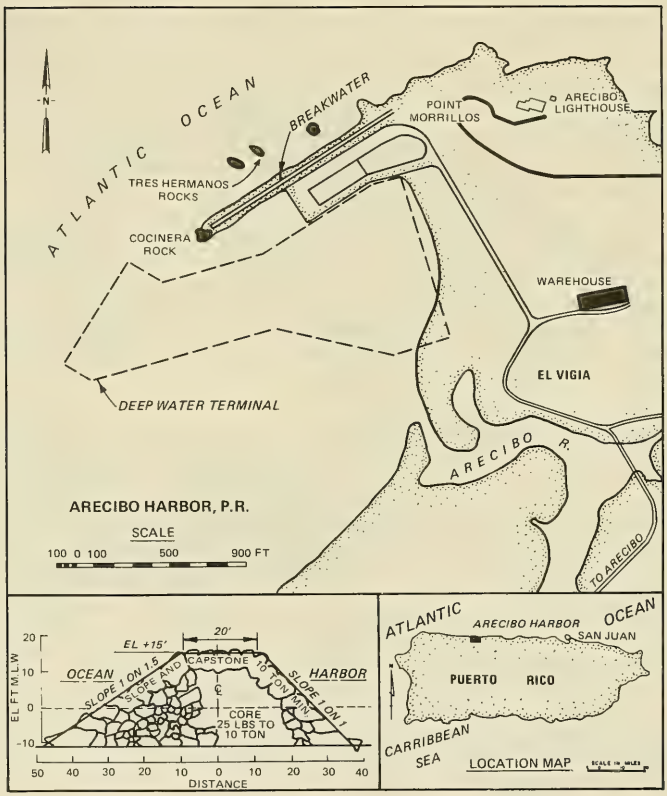
Figure 41. Arecibo Harbor, Puerto Rico

1983	A field inspection and a condition survey were made to identify damaged areas for rehabilitation purposes. The general damage (Figure 42) was above mlw, and the ocean-side slope of the submerged part of the structure had increased to 1V:2H or greater. In particular, about 160 ft of the seaward end had subsided to approximately mlw. Several areas on the trunk section had unprotected core stone on either side of the structure.
1984	Rehabilitation of the breakwater consisted of rebuilding the outer end of the breakwater and restoring damaged sections by placing about 42,000 tons of armor stone, ranging in size from 11 to 29 tons (Figure 42). A double layer of armor stones was provided on the seaward side of the structure along a reach beginning about 350 ft from the shore end of the breakwater and extended toward the outer end, a distance of 450 ft. A double layer of armor stone was placed on both sides of the structure for the next 265 ft. The remaining 155 ft, at the seaward end of the structure, was rebuilt to +15 ft mlw, as were the other sections. The crest of the damaged sections was restored to a width of about 26 ft for the first 800-ft reach. The crest of the outer 420-ft section was widened to about 36 ft, flaring out to about 50 ft at the extreme outer end. Armor stone slopes for the ocean and harbor sides were 1V:2.3H and 1V:1.5H, respectively. Based on utilizing local stone, the cost of the work was estimated to be $3,900,000. The design analysis used was the

Date(s)	Construction and Rehabilitation History
1984 (Cont)	WIS 20-year wave hindcast study (Corson, et al. 1982) together with a wave shoaling model (Seelig and Ahrens 1980) and a stability equation presented by the Danish Hydraulic Institute (Gravesen et al. 1979) in addition to SPM (1984) procedures.
1985	The structure is in excellent condition.
